New York State Department of Transportation  
Yellow Flag NB2358W021

BIN: 1065318

Feature Carried: 278I278IX2M23027

Feature Crossed: 6TH AVENUE

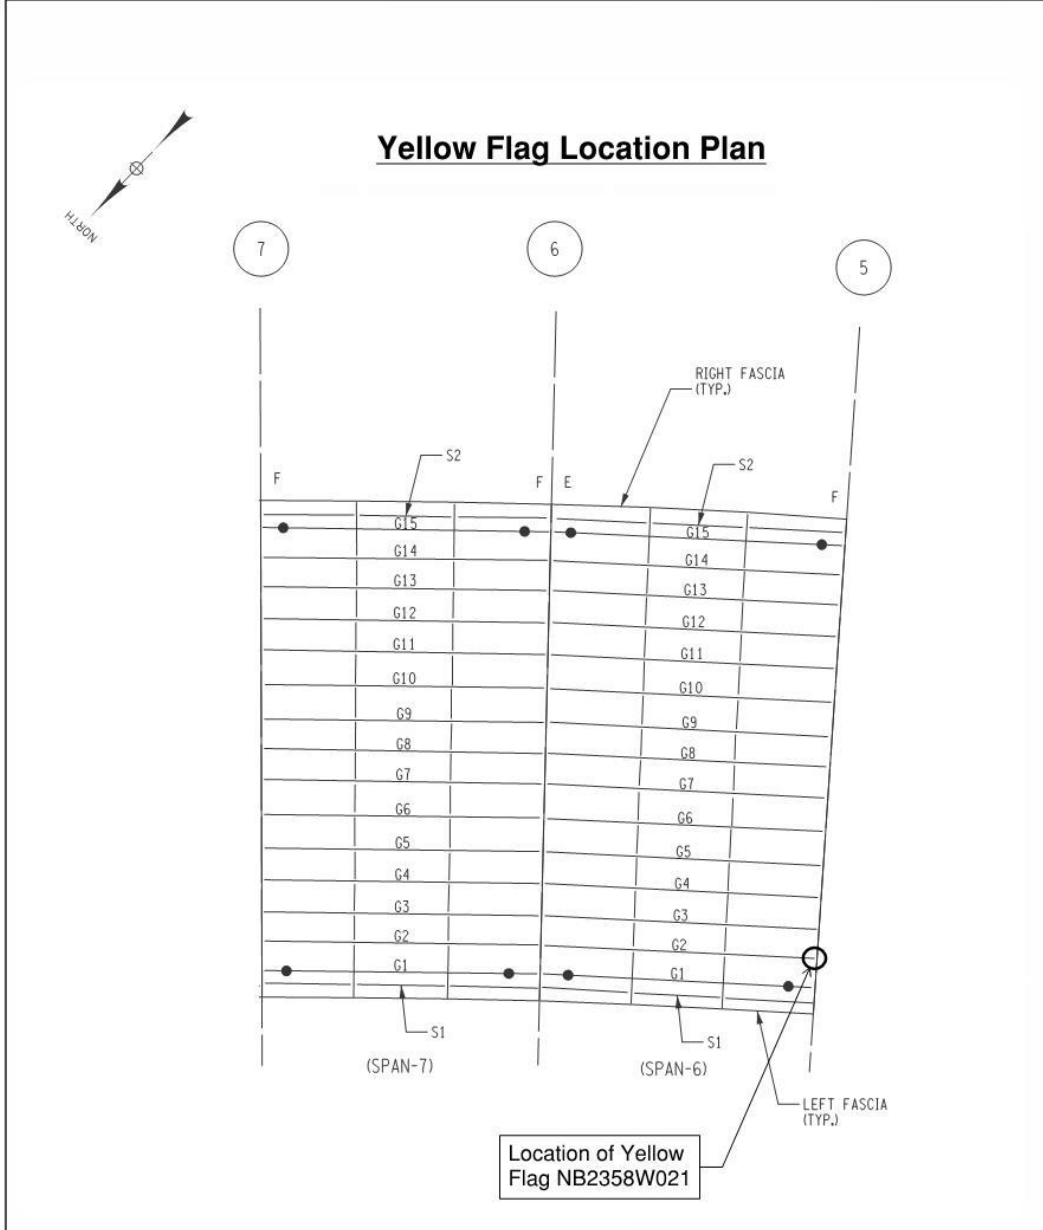
Photo Number: **1**

Attachment Description: Flag Location Plan

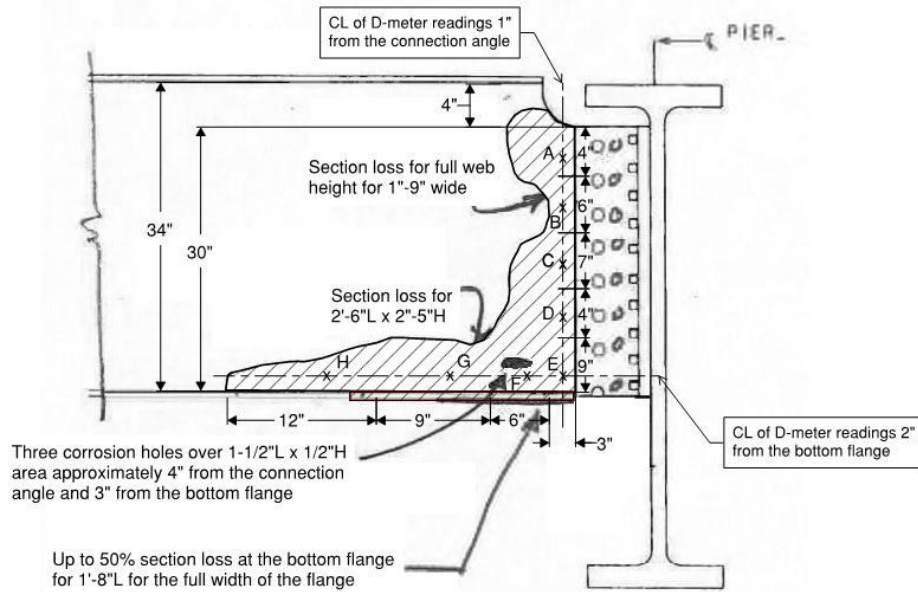
Photo Number: 2

The end of Girder G2 in Span 6 at Pier 5 exhibits severe section loss for 1"-9" wide for the full height of the girder web along the connection angle with 0.20"-0.50" remaining thickness measured (RTM) resulting in approximately 25% to 70% section loss with average 48% section loss. The lower girder web above the bottom flange exhibits severe section loss for 2'-6" long for 2"-5" high with 0.20"-0.37" RTM resulting in approximately 45%-70% section loss with average 58% section loss. (Photos #4 and #5) The girder web exhibits three corrosion holes over 1'-1/2" x 1/2" area approximately 4" from the connection angle and 3" from the bottom flange (Photo #6). The overall shear web area section loss is approximately 51%. Also, the bottom flange exhibits up to 50% section loss for 1'-8" long for the full width of the flange (Photo #7). (refer to Flag Condition Sketch Photo #2 for more details)

Point	D-Meter Readings (in)	Calculated Section Loss (%)
A	0.50	25%
B	0.41	39%
C	0.37	45%
D	0.27	60%
E	0.20	70%
F	0.25	63%
G	0.32	52%
H	0.37	45%

$$4" \times 0.50" [\text{Point A}] + 6" \times 0.41" [\text{Point B}] + 7" \times 0.37" [\text{Point C}] + 4" \times 0.27" [\text{Point D}] + 9" \times 0.20" [\text{Point E}] = 9.93 \text{ in}^2$$

$$[(30" \times 0.667") - 9.93 \text{ in}^2] / (30" \times 0.667") \times 100 = 51\%$$

$$(25\% [\text{Point A}] + 39\% [\text{Point B}] + 45\% [\text{Point C}] + 60\% [\text{Point D}] + 70\% [\text{Point E}]) / 5 = 48\%$$

$$(70\% [\text{Point E}] + 63\% [\text{Point F}] + 52\% [\text{Point G}] + 45\% [\text{Point H}]) / 4 = 58\%$$

-As-measured web thickness is approximately 0.667".

Attachment Description: Flag Condition Sketch

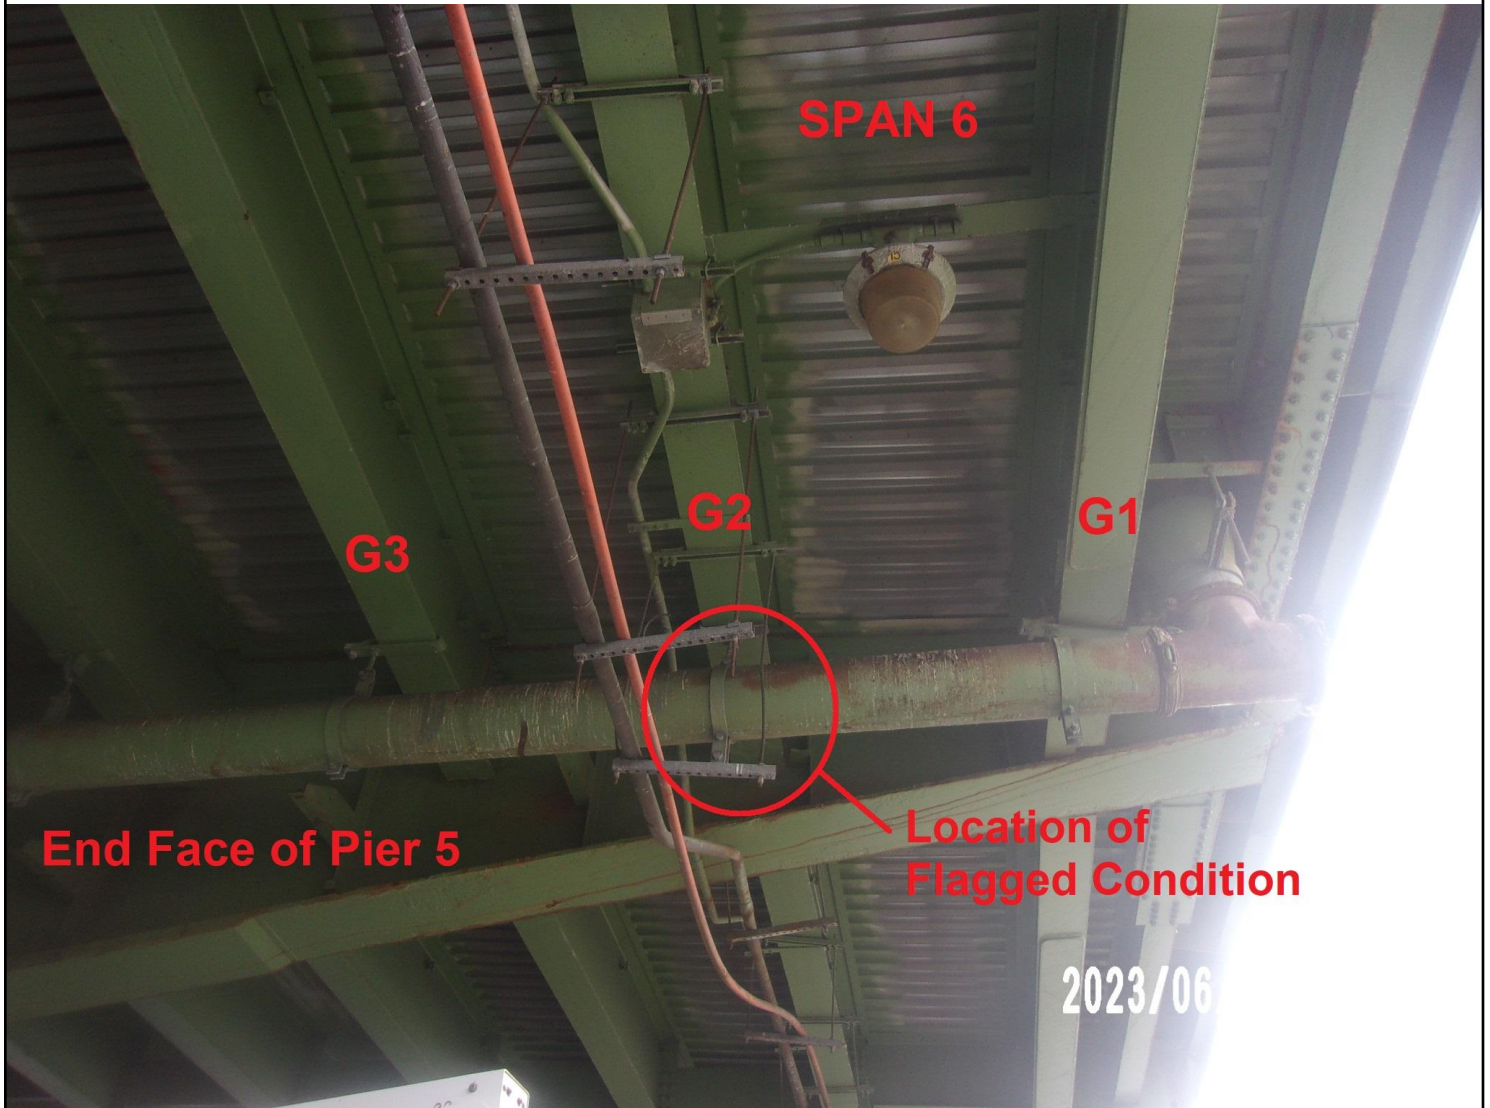
Photo Number: 3

**Attachment Description:** General view of the flagged condition at Girder G2 in Span 6 at Pier 5. Looking Begin.

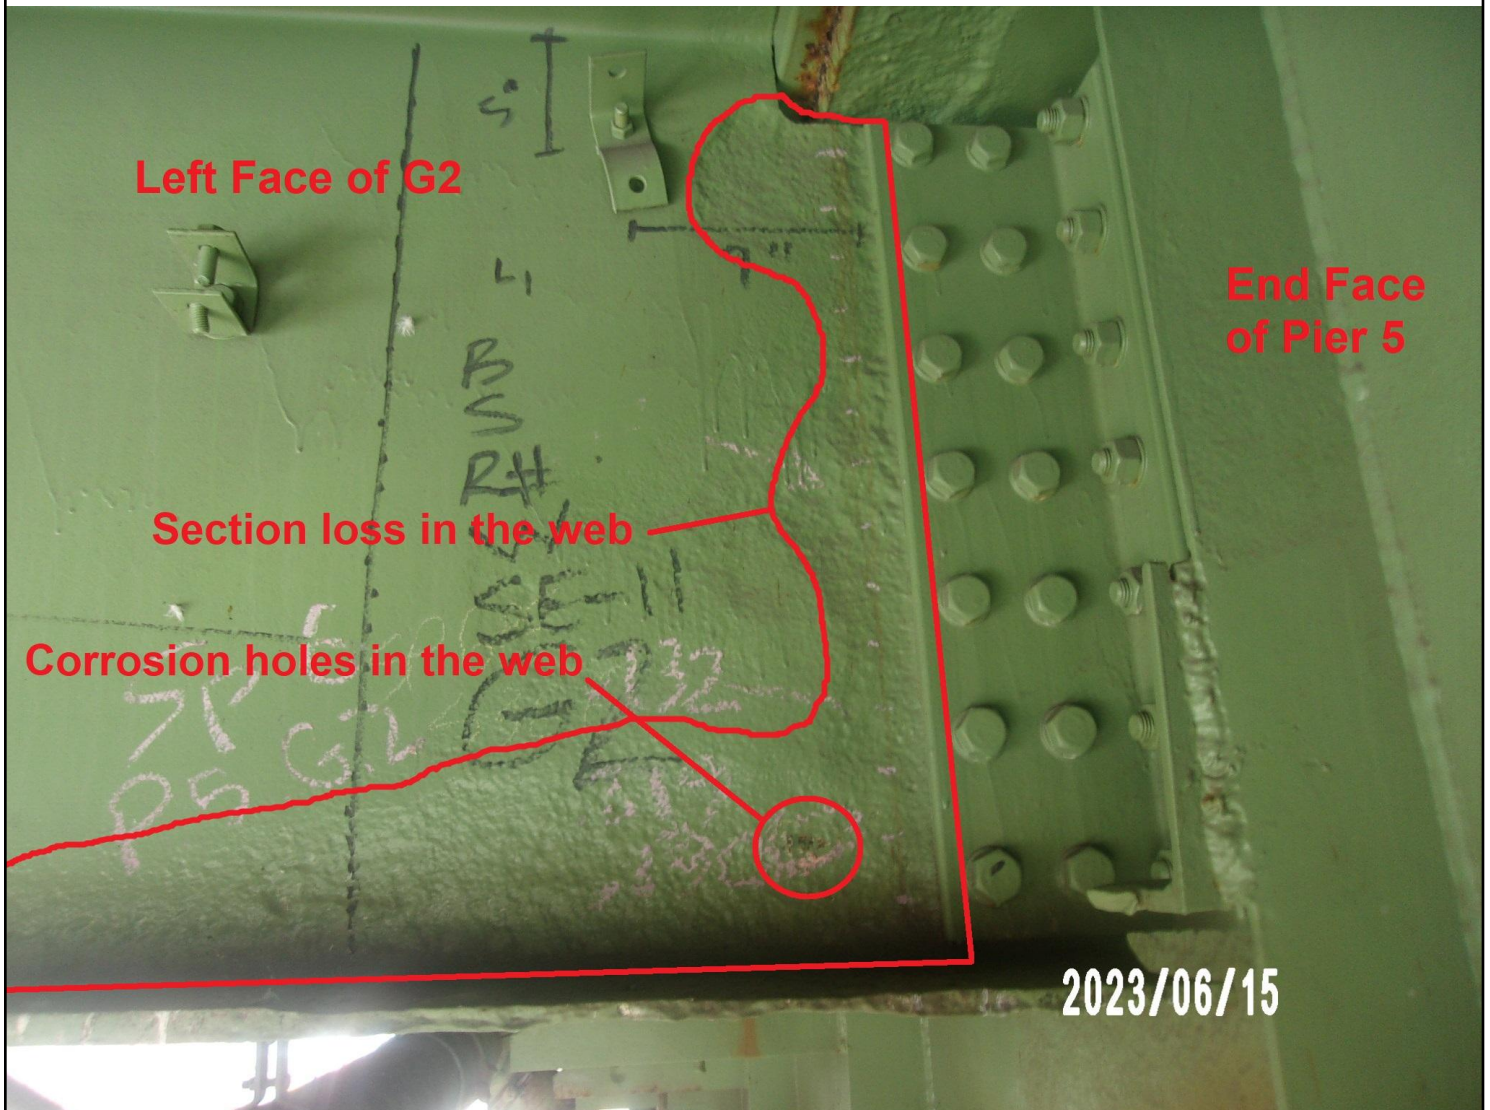
Photo Number: 4

**Attachment Description:** The left face of Girder G2 in Span 6 at Pier 5. The full web height along the connection angle exhibits 25% to 70% section loss with average 48% section loss. The lower web above the bottom flange exhibits 45%-70% section loss with average 58% section loss. The lower web exhibits three corrosion holes over 1-1/2" x 1/2" area. The overall shear web area section loss is 51%. Looking Right.

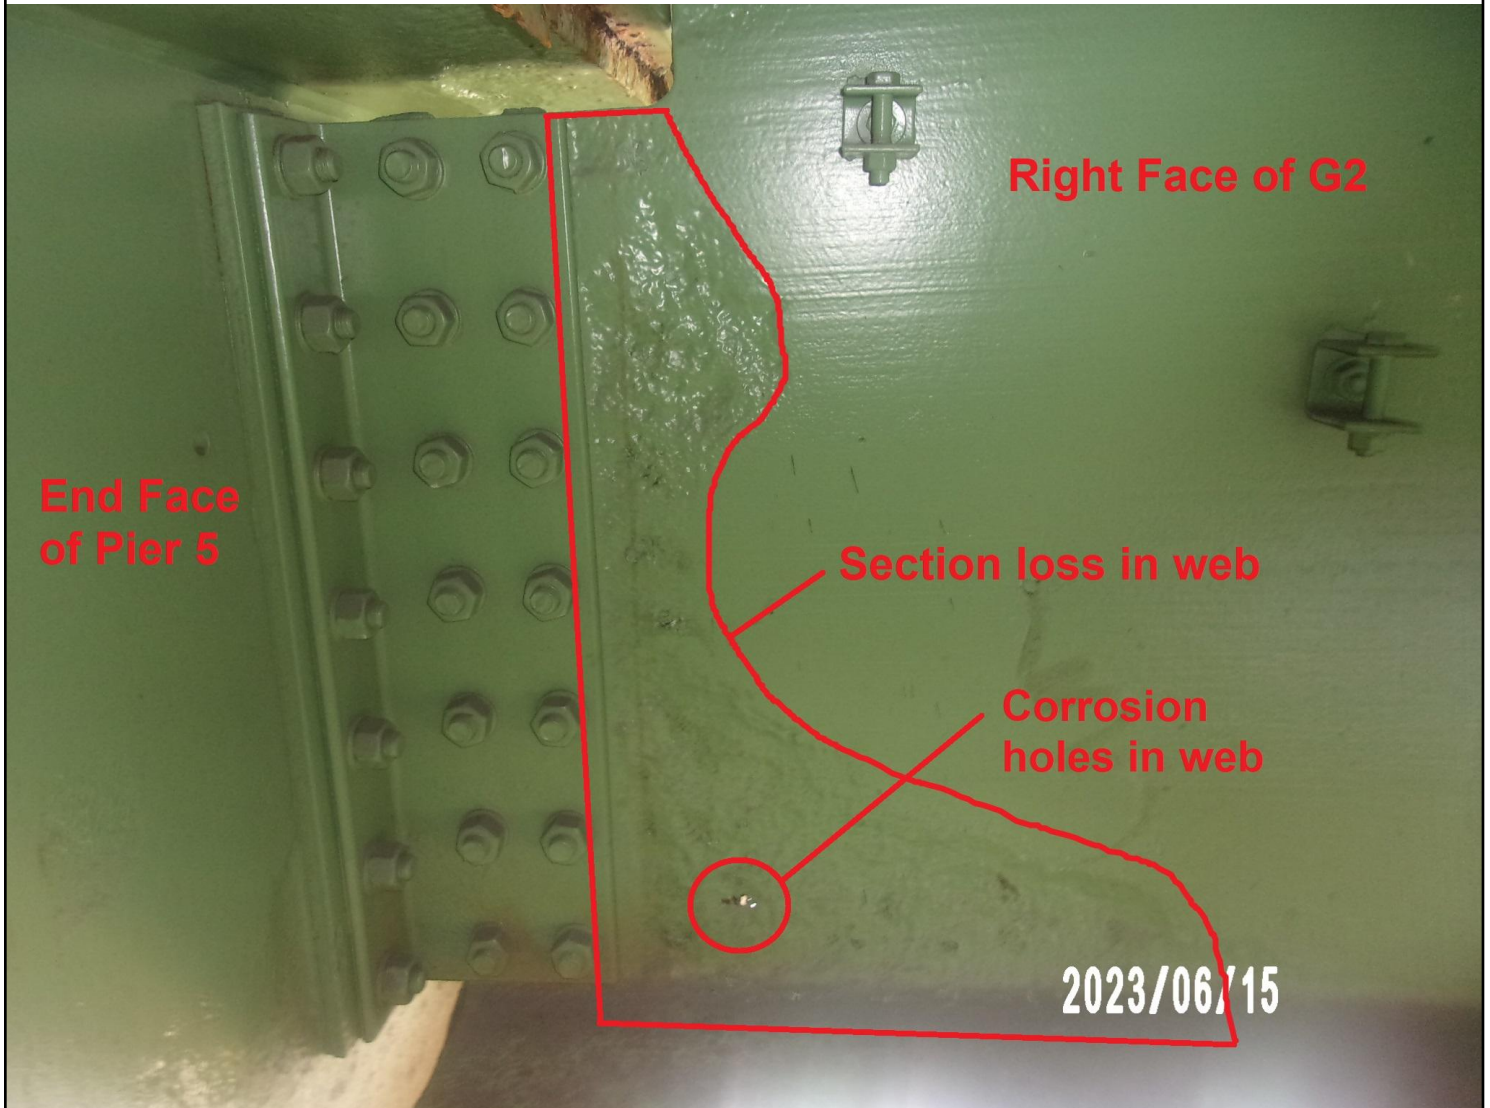
Photo Number: 5

**Attachment Description:** The right face of Girder G2 in Span 6 at Pier 5. The full web height along the connection angle exhibits 25% to 70% section loss with average 48% section loss. The lower web above the bottom flange exhibits 45%-70% section loss with average 58% section loss. The lower web exhibits three corrosion holes over 1-1/2" x 1/2" area. The overall shear web area section loss is 51%. Looking Left.

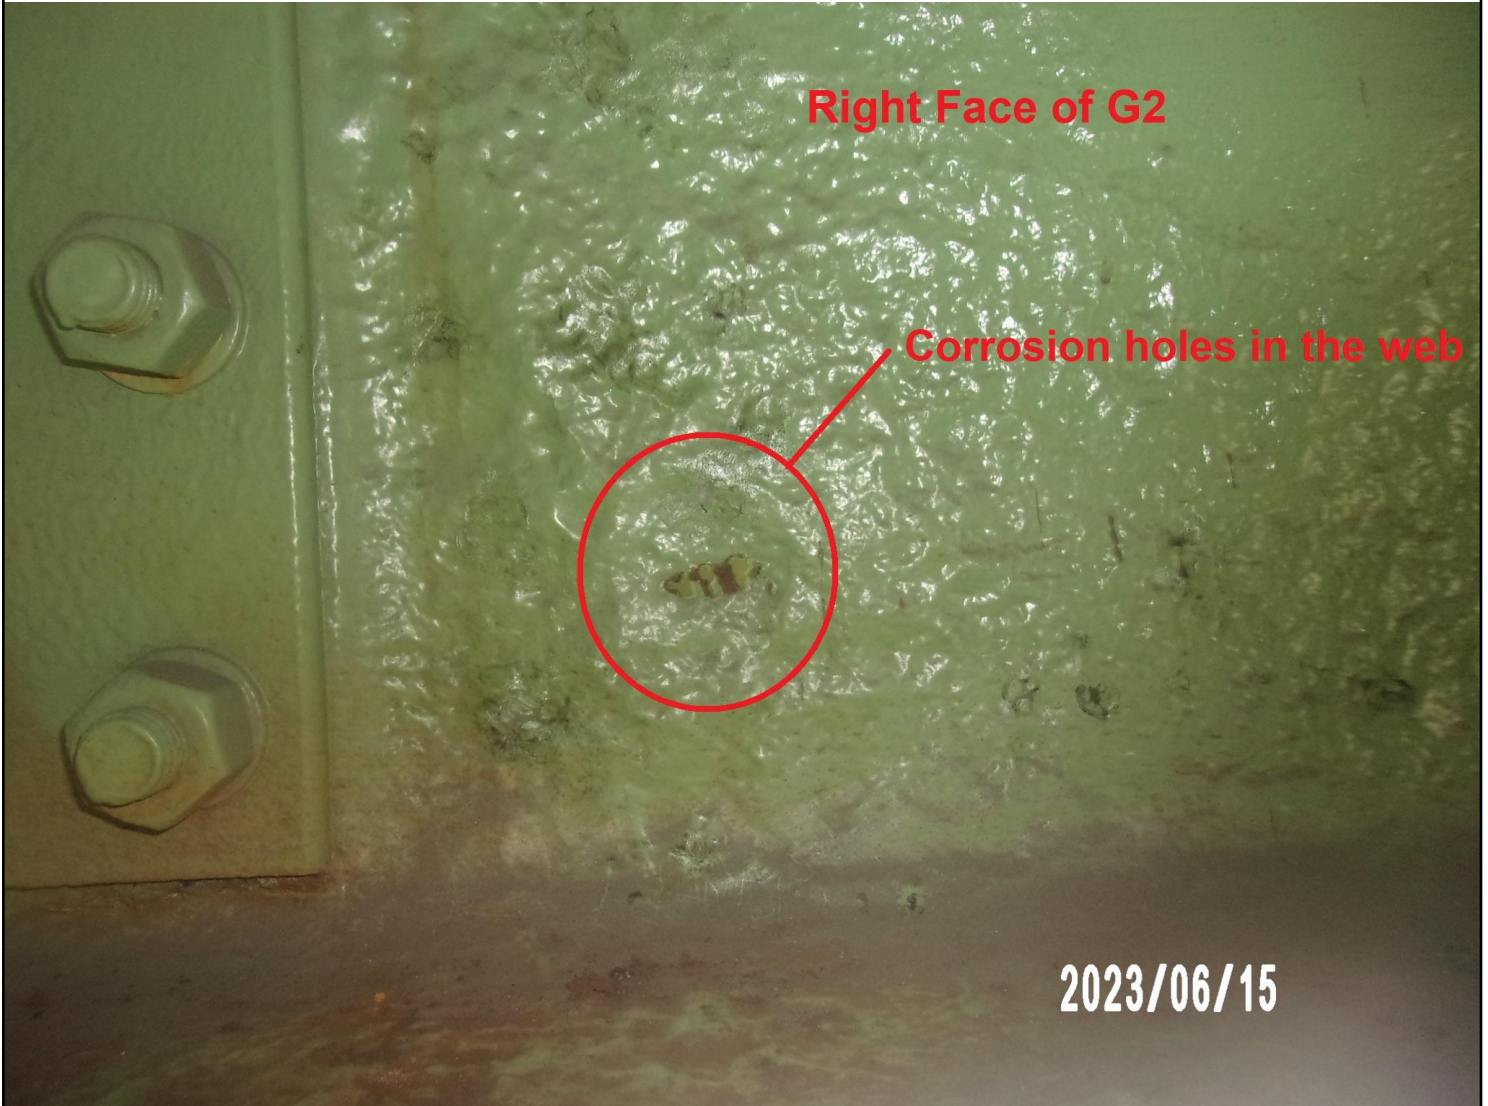
Photo Number: 6

**Attachment Description:** The right face of Girder G2 in Span 6 at Pier 5. Close up view of the three corrosion holes over 1-1/2" x 1/2" area in the lower web. Looking Left.

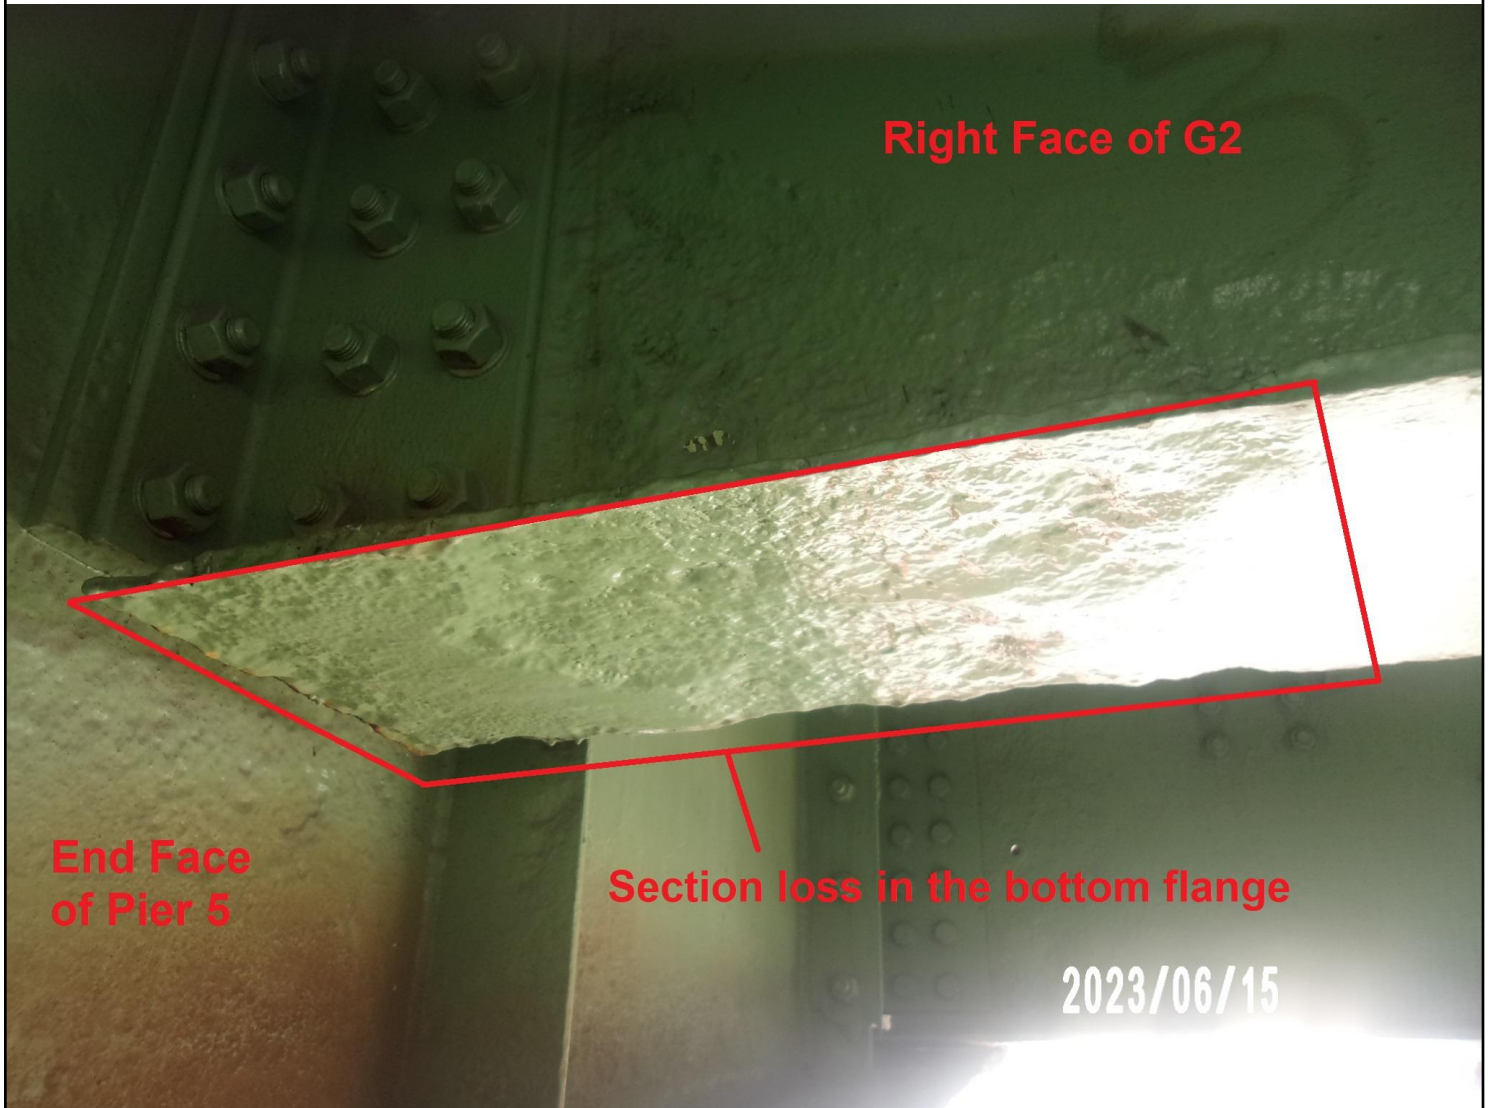
Photo Number: 7

**Attachment Description:** The underside of Girder G2 in Span 6 at Pier 5. The bottom flange exhibits up to 50% section loss for the full width of the flange. Looking Begin and Left.
